Velosi China Inspection Report

Client: Metals International Limited	PO No: 09786	
SO No.: N/A	Job No.: N/A	Report No.: IR-08162
Client Account Code: N/A	WO No.: N/A	Date of Visit: 15, Dec, 2013

Item No.	Quantity (pcs)	Description
1	225	ASME SA335 P22 (PART1) 508*26.19;
2	62	ASME SA335 P11 (PART1) 508*9.53;
3	84	ASME SA335 P11 (PART1) 457.2*14.27;
4	93	ASTM A106 GR.B (PART1) 323.9*10.31;
5	112	ASTM A106 GR.B (PART1) 273.1*9.27;
6	51	ASTM A106 GR.B (PART2) 273.1*9.27;
7	81	ASTM A106 GR.B (PART2) 406.4*9.53;
8	63	ASTM A106 GR.B (PART1) 457.2*14.27;

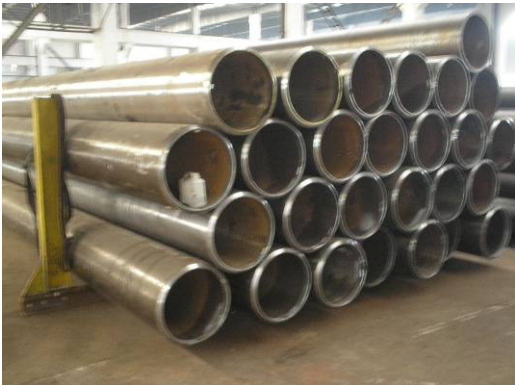
The writer verified the quantity of pipes for all items. The tolerances is -0/+3% per item, some items have exceeded the limit a little, such as ASME SA335 P11 (PART1) 457.2*14.27 (required length: 30meter; actual: 31.91meter), ASTM A106 GR.B (PART1) 323.9*10.31 (required length: 30meter; actual: 31.10) and ASTM A106 GR.B (PART1) 273.1*9.27 (required length: 110meter; actual: 114.28meter). The manufacturer explained that they had confirmed the quantity with client, so accepted.

The writer checked the appearance for all pipes; No burrs, scales and other defects were found on the inside or outside surface, but some mill scale and scrap iron were found inside the pipes, the manufacturer has ensured that they would clean them before shipping.

<p>Photo 1. Appearance and quantity check.</p>

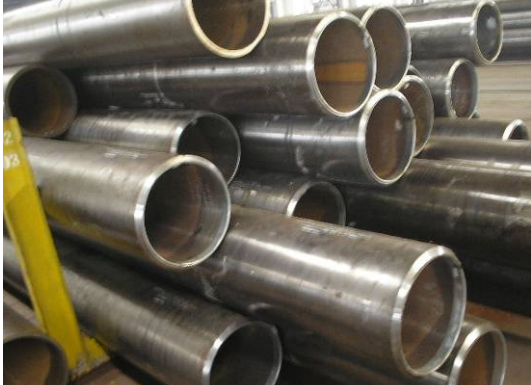
<p>Photo 2. Appearance and quantity check.</p>

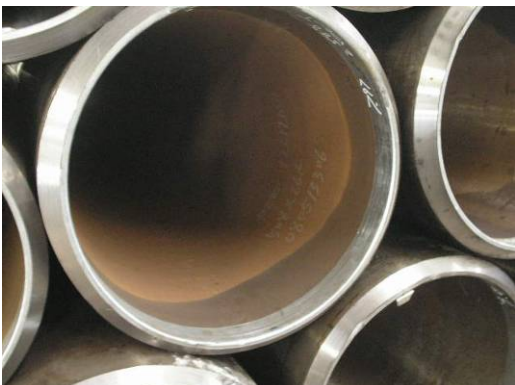
<p>Photo 5. Inner surface check.</p>

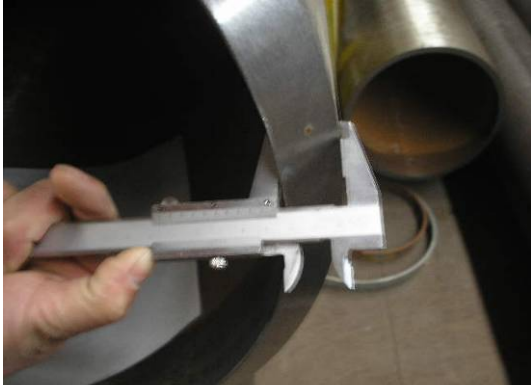
The writer also randomly checked the outside diameter and wall thickness. The tolerance of wall thickness is $\pm 12.5\%$; and the tolerance of outside diameter is $-0.79/+2.38$ (NPS over 8 to 18 inches) and $-0.79/+3.18$ (NPS over 18 to 26 inches). All measured diameter were in control limits.

<p>Photo 6. Dimension check.</p>

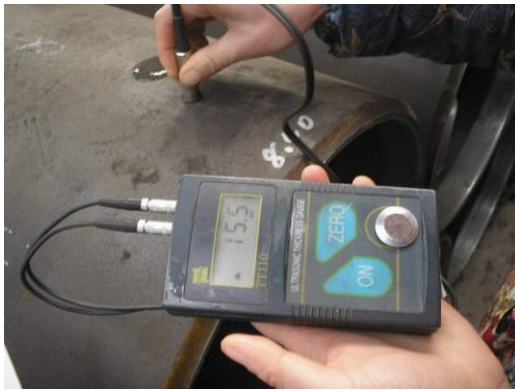
Photo 7.
Dimension
check.

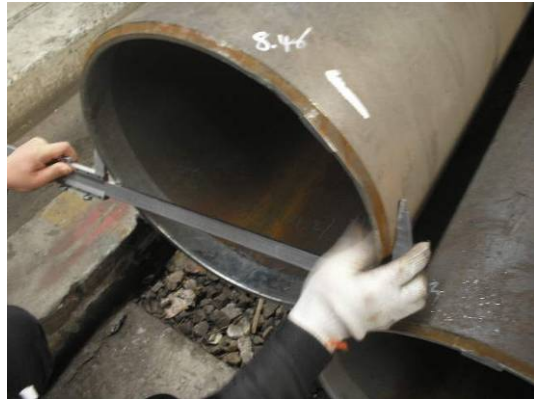
Photo 8.
Dimension
check.

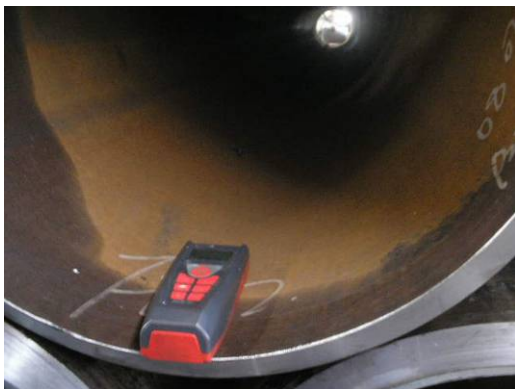
Photo 9.
Dimension
check.

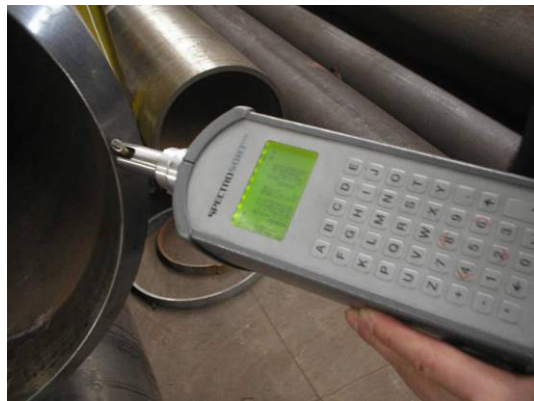
The writer randomly witnessed the PMI tests for all item pipes, all tested results have been recorded in photos, and the writer also checked the results according to specifications, no chemical components were out of control limits.

Photo 10.
PMI test.

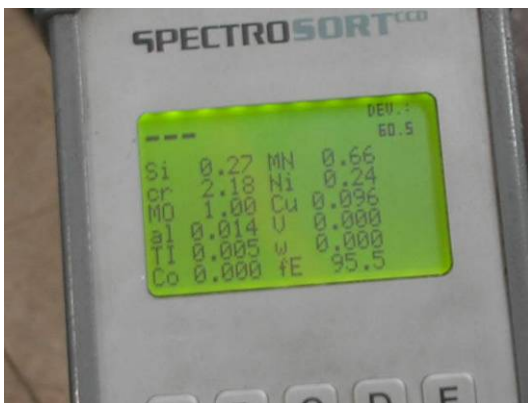
Photo 11.
PMI test.

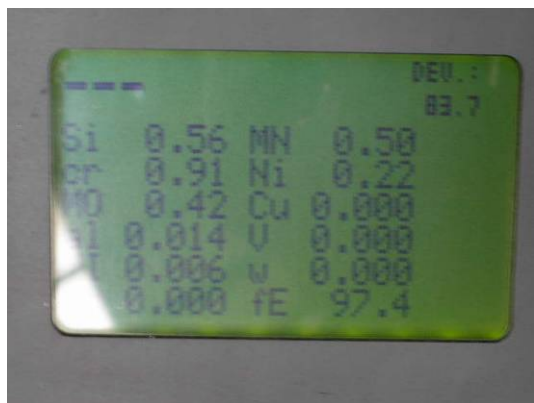
Photo 12.
PMI test.

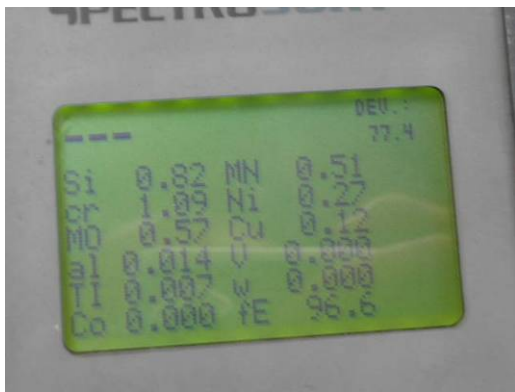
Photo 13.
PMI test.

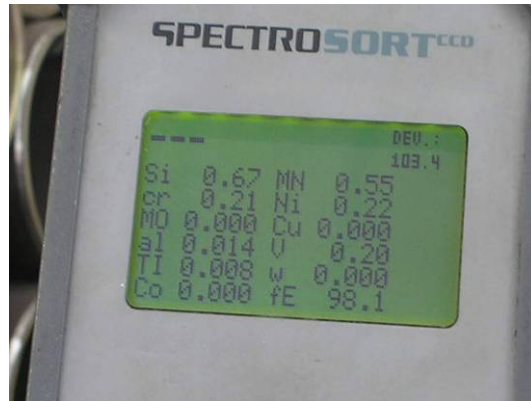
Photo 14.
PMI test.

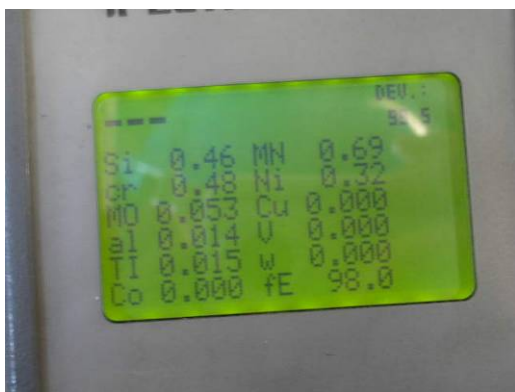
Photo 15.
PMI test.

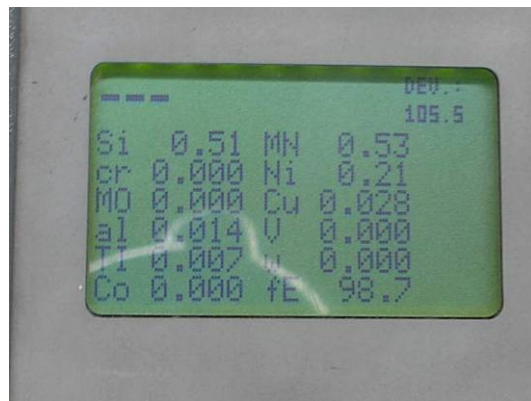
Photo 16.
PMI test.
