## INSPECTION REPORT

Report No.: MIL P09829-4

Inspection Subject:	Seamless Heat Exchanger Tube for Ambarli Project, Turkey				
Specification:	ASME SA213 T11/T22	Inspector:	Lin Gaojie

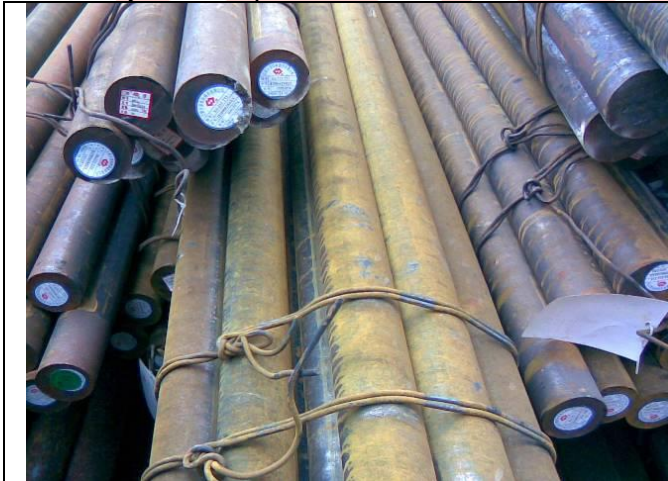
We had checked the visual quality and chemical analysis of the new raw materials, the Heat No. of which are H10906353 and H10906354.

They are all up to snuff.

Raw materials

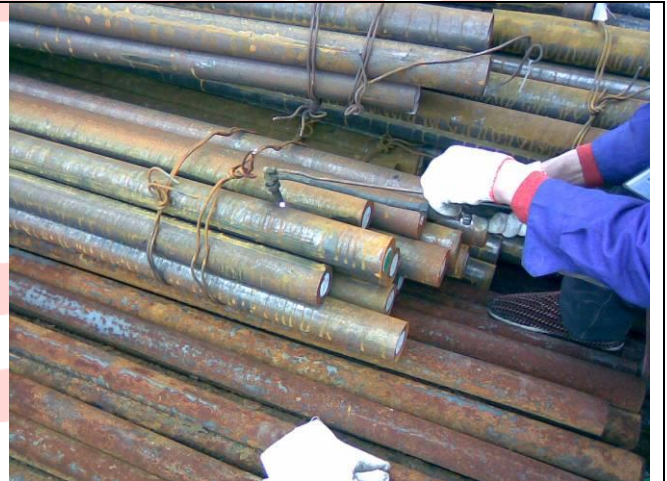
Cutting sample for chemical analysis

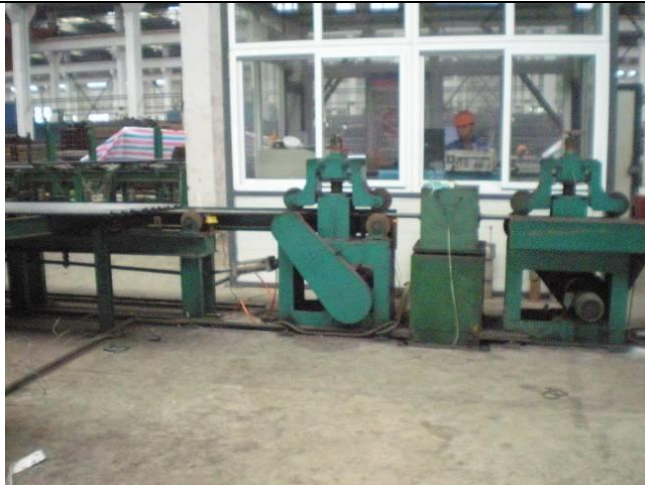
We had overseen the operation and checked the NDT Report. The notches for Ultrasonic Test and Eddy Current are qualified according to the norm.

Eddy Current Testing

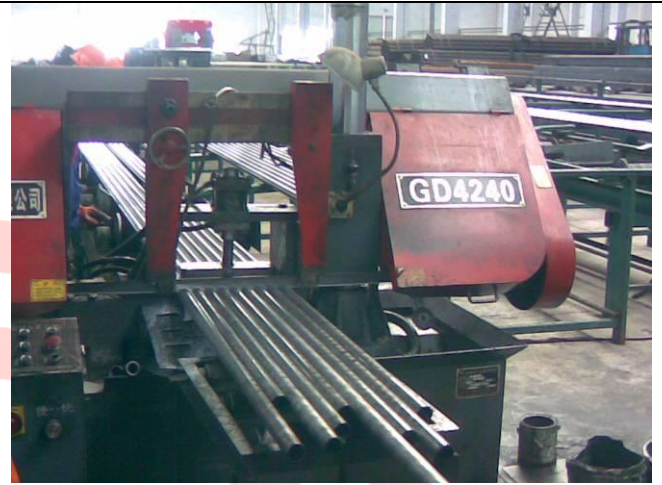
Being cut off

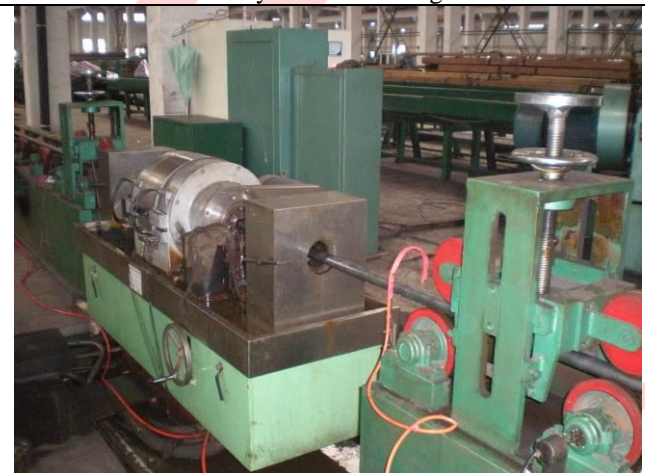
Ultrasonic Test

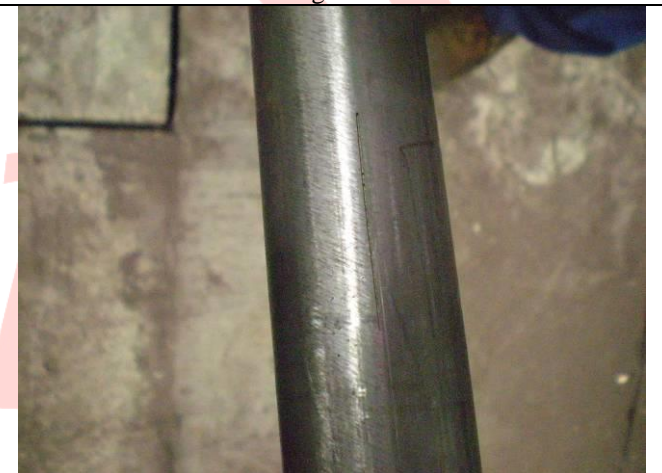
Notch for Ultrasonic Test

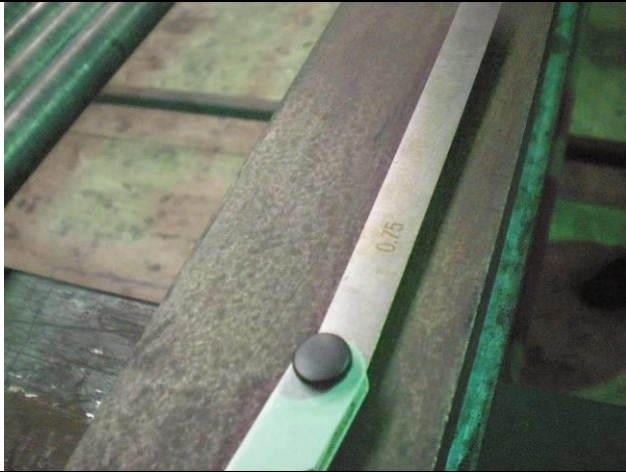
The spec of feeler leaf that we used is 0.75mm, while the maximum curvature is 0.89mm/m.

Feeler gauge

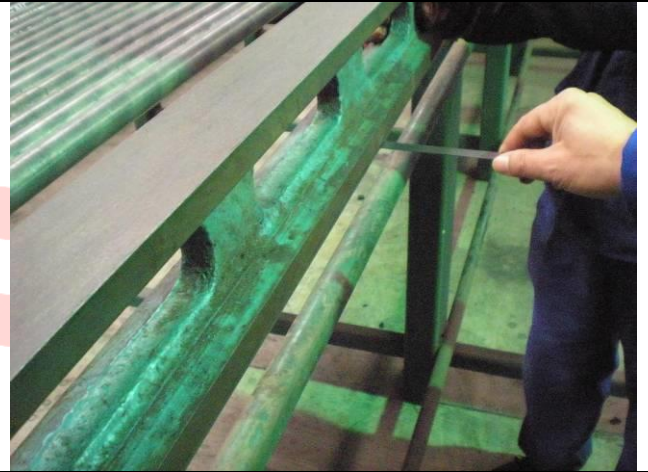
Measuring the straightness

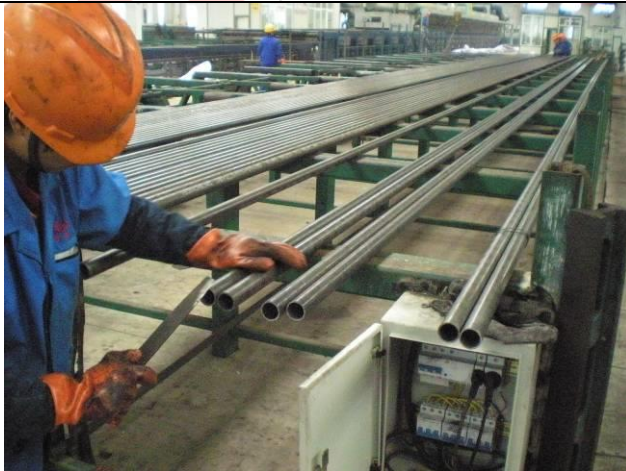
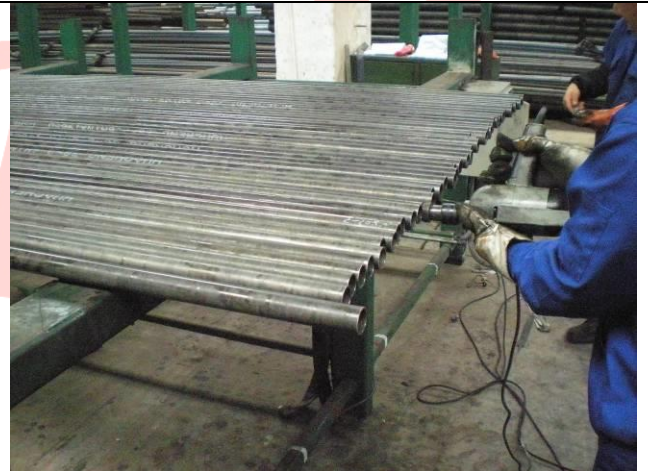
Tube ends have squared cut and are free from excessive burrs.

Wiping off the excessive burrs

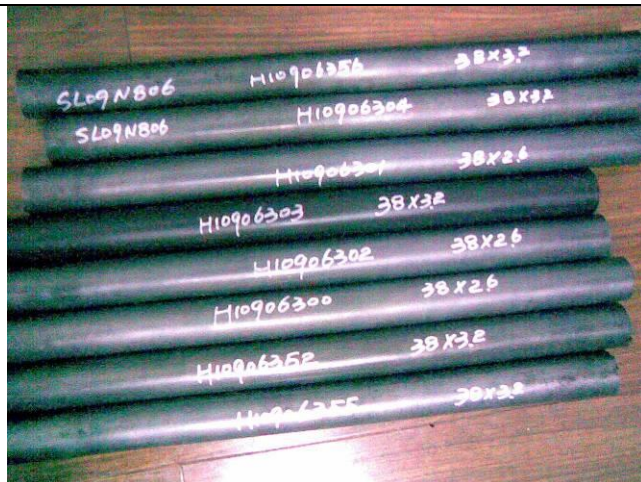
There are about 10 samples having been taken, and we had verified them. The rest samples will be cut off on the witness of Moody Inspector according to the decision of our meeting on Nov. 20<sup>th</sup>, 2009.

Samples

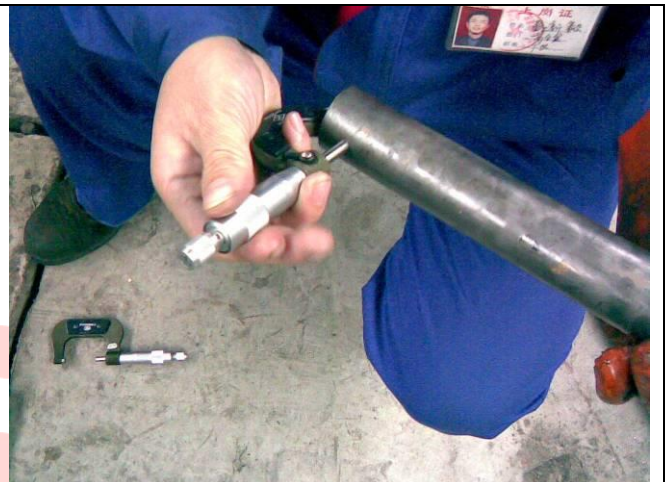
Gauging

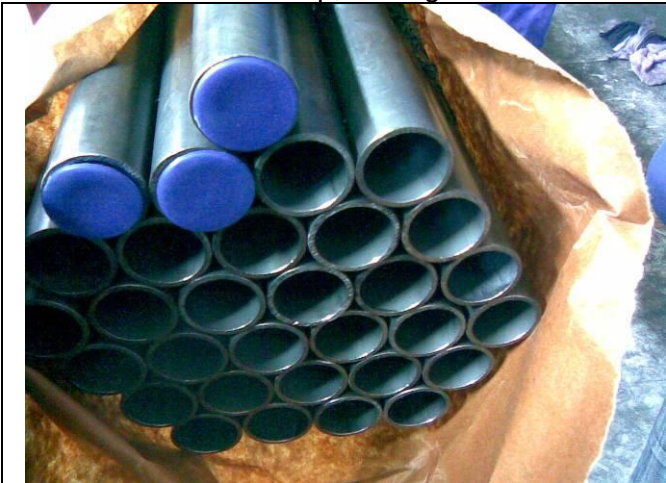
Plugs on tube ends

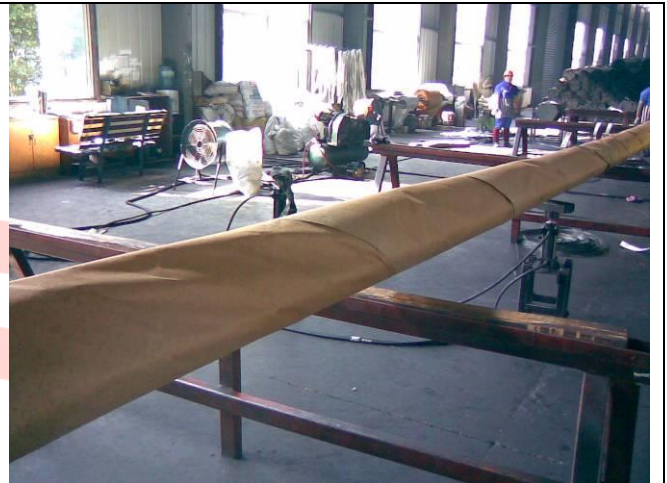
The first wrapping: Moistureproof paper

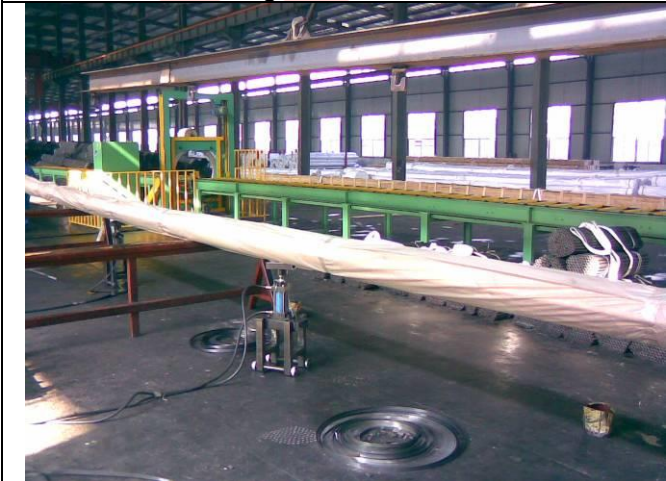
The second wrapping: Ploy bag

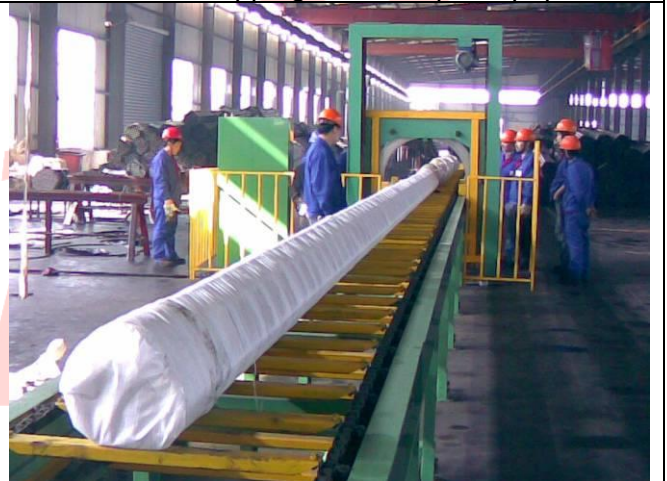
The third wrapping: Polypropylene knitted bag

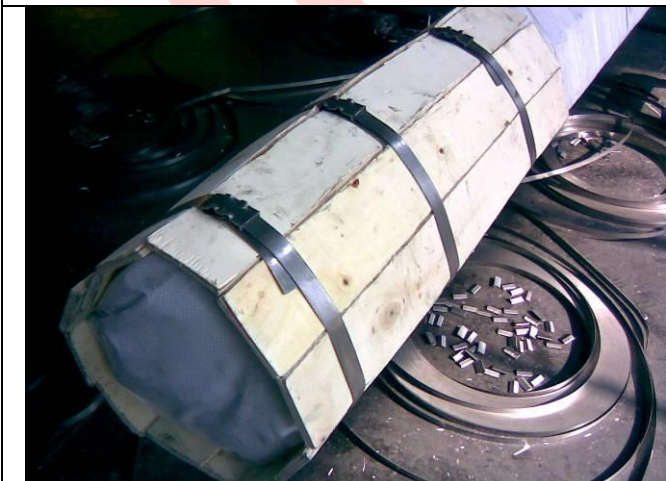
The last wrapping: Batten and metal band

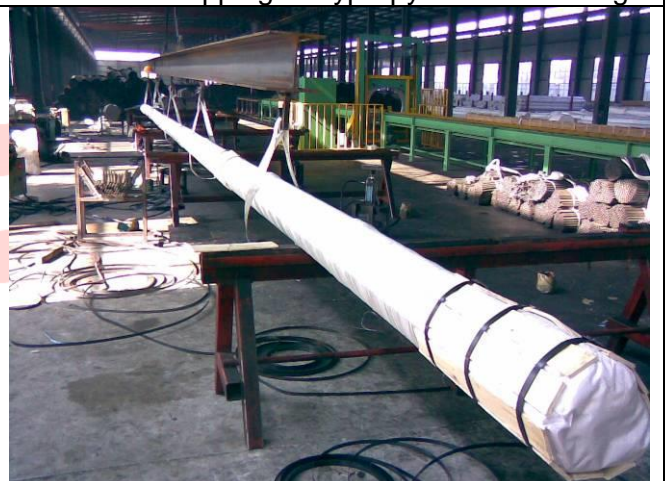
The final packaging

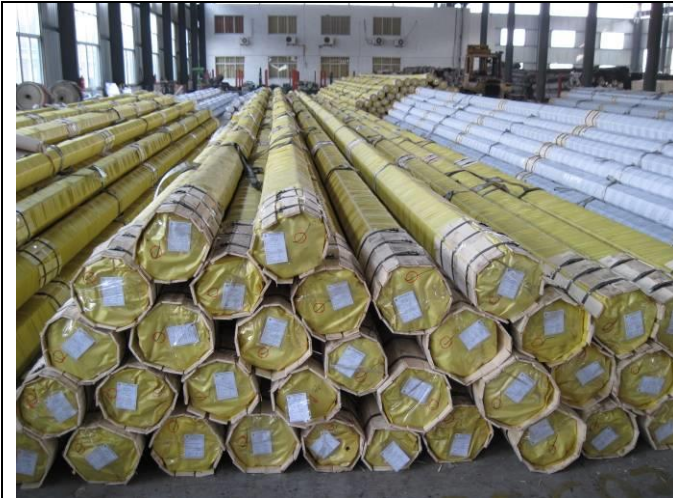
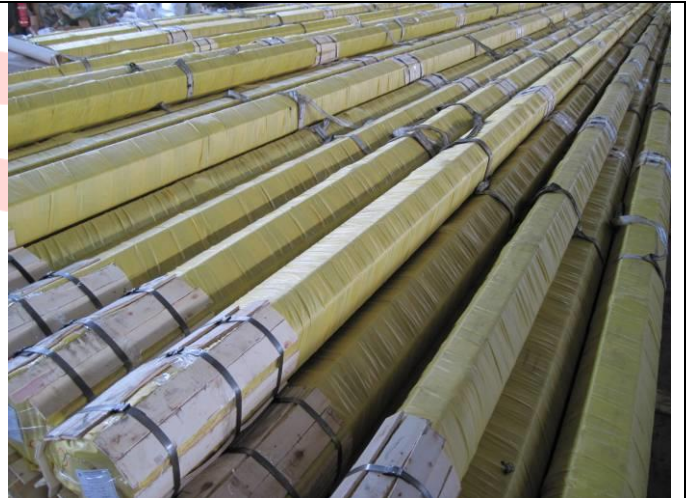
The tubes

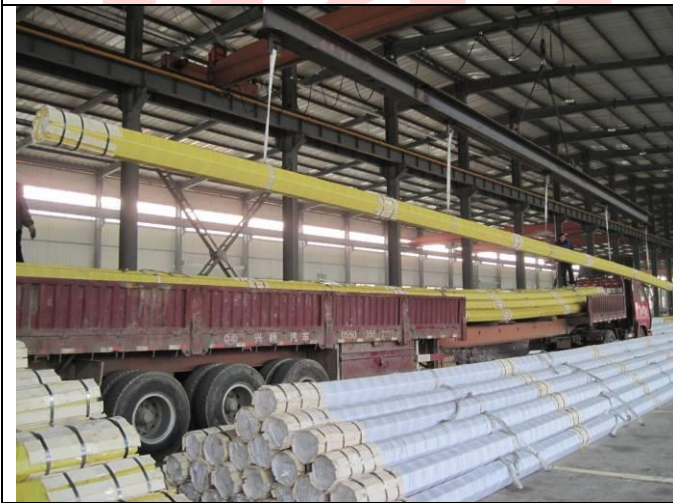
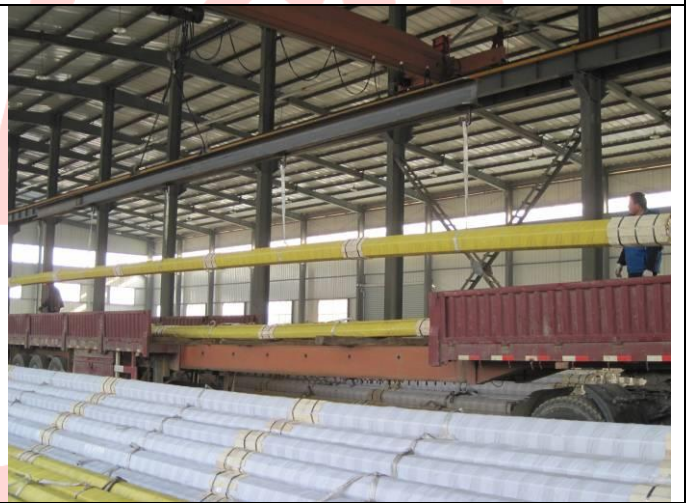
The first batch of cargo had been carried by truck to the storage where the tubes will be baled into big bundle. We had overseen the operation and the tubes are good after being loaded into the truck.

Being loaded into the truck

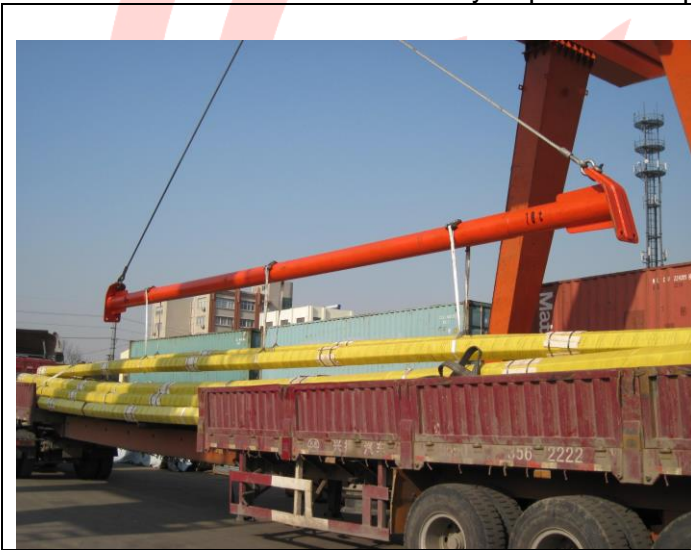
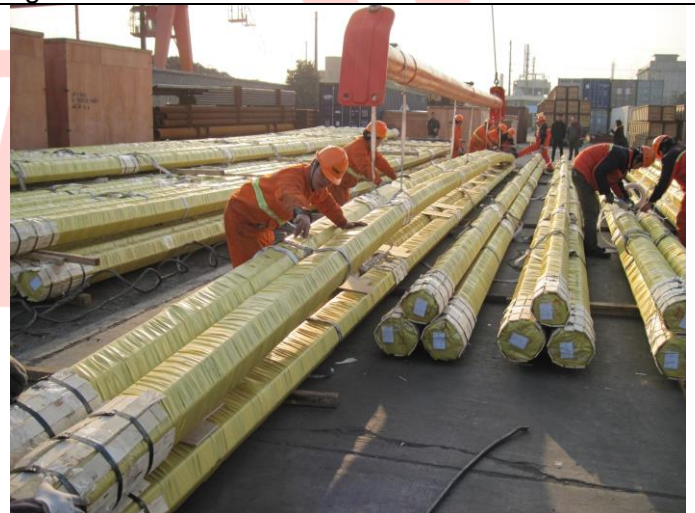
Discharging

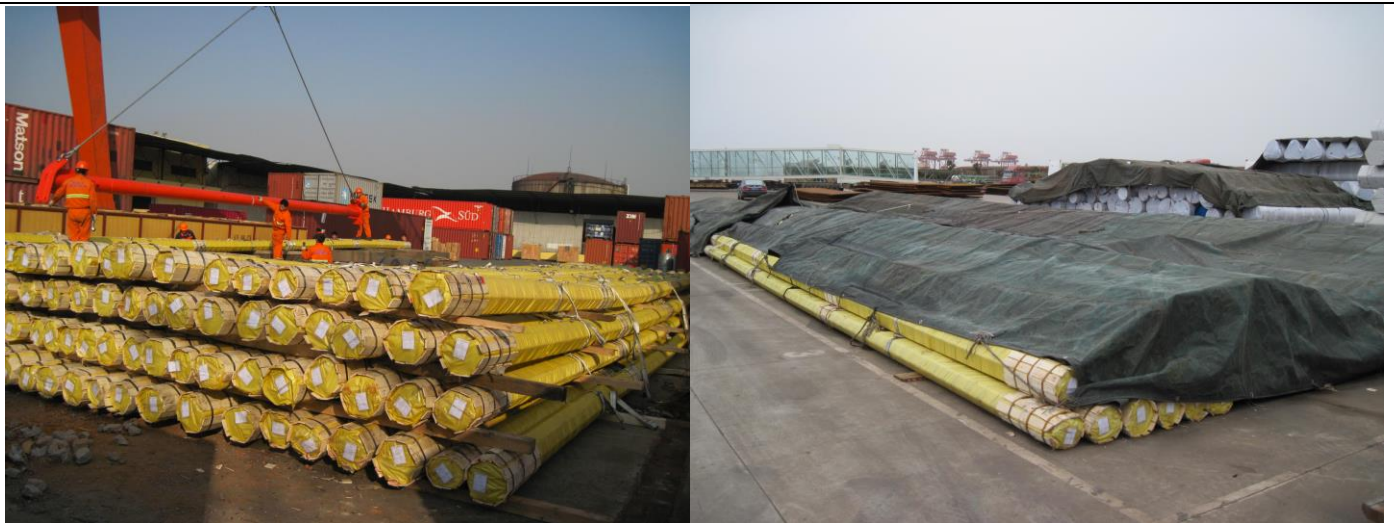
The tubes had been covered by tarp before shipping.

**Storage**
