INSPECTION REPORT

Report No.: MIL 100601-01A1

Inspection Subject:	Copper Tubes-Pancake Coils			
Manufacturer:	Metals International Limited			
Specification:	ASTM B280	Inspector:	Lin Gaojie	Stamp No:

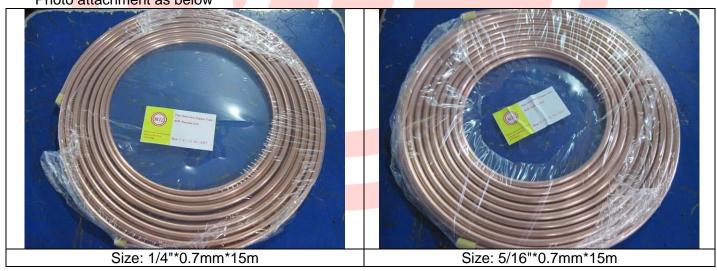
The tubes were good except some imperfection, and the details were as followed:

1) The outside surface of tubes was bright;

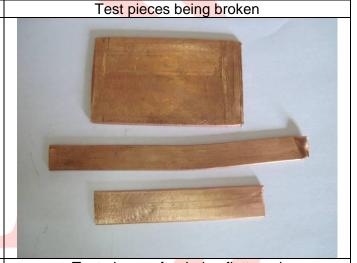
3) The flattening test of three test pieces was qualified. Photo attachment as below

Test pieces after being flattened

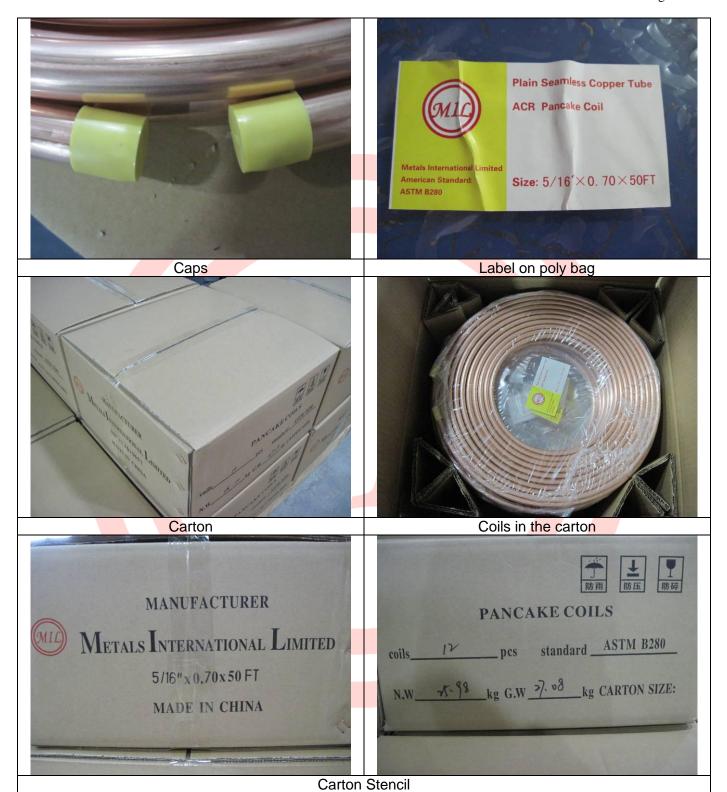
The tubes were plugged with caps on the end first, then encapsulated by the poly bags and put into cartons, lastly bundled by polywood tray. Details as below:

- 1) There were 123 cartons and 3 trays;
- 2) There was one label on each poly bag and informations were written on the carton;
- 3) The shipping mark will be pasted on the tray.
