## INSPECTION REPORT

Report No.: MIL P09829-4

Inspection Subject:	Seamless Heat Exchanger Tube for Ambarli Project, Turkey				
Specification:	ASME SA213 T11/T22	Inspector:	Lin Gaojie

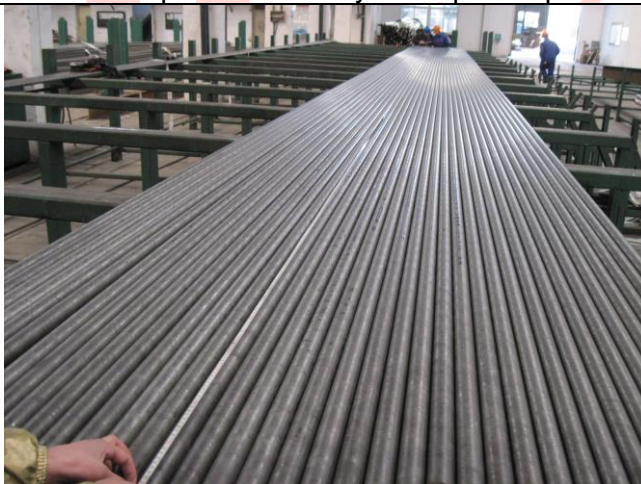
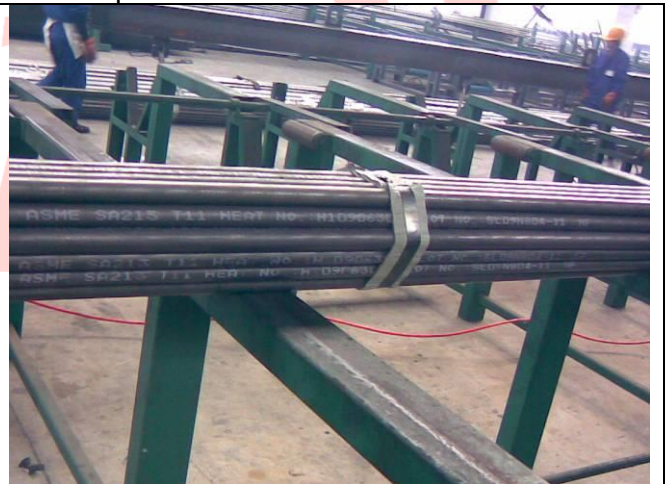
Moody Inspector chose three bundles of tubes randomly for inspecting.  
The mill provided Moody the report of production and inspection.

Moody Inspection

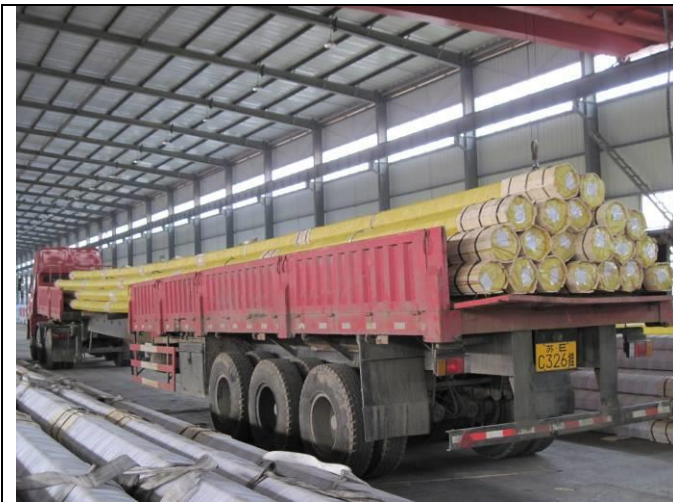
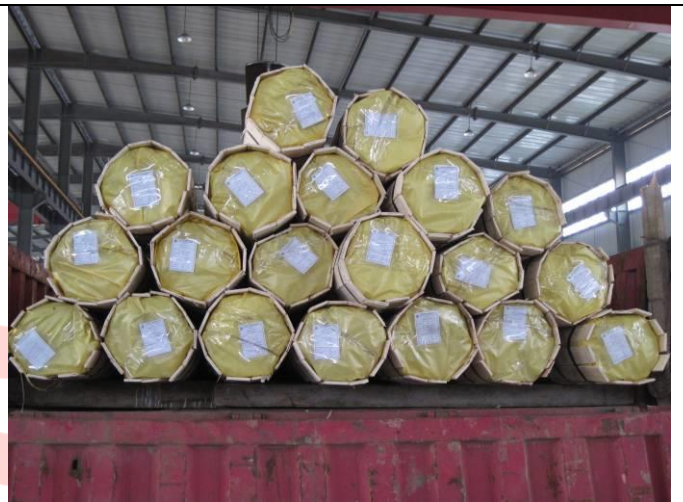
The first batch of cargo had been carried by truck to the storage where the tubes will be baled into big bundle. We had overseen the operation and the tubes are good after being loaded into the truck.

Loaded onto Truck  
Truck 2
